**OPTIONAL DETERMINATION OF NON-SIGNIFICANCE (DNS) NOTICE MATERIALS**

File No. 18-132451-LD  
Project Name/Address: 555 108<sup>th</sup> Avenue NE / 555 108<sup>th</sup> Avenue NE  
Planner: Laurie Tyler  
Phone Number: (425)-452-2728

## **SEPA Environmental Checklist**

# 555—108th Ave NE Environmental Checklist

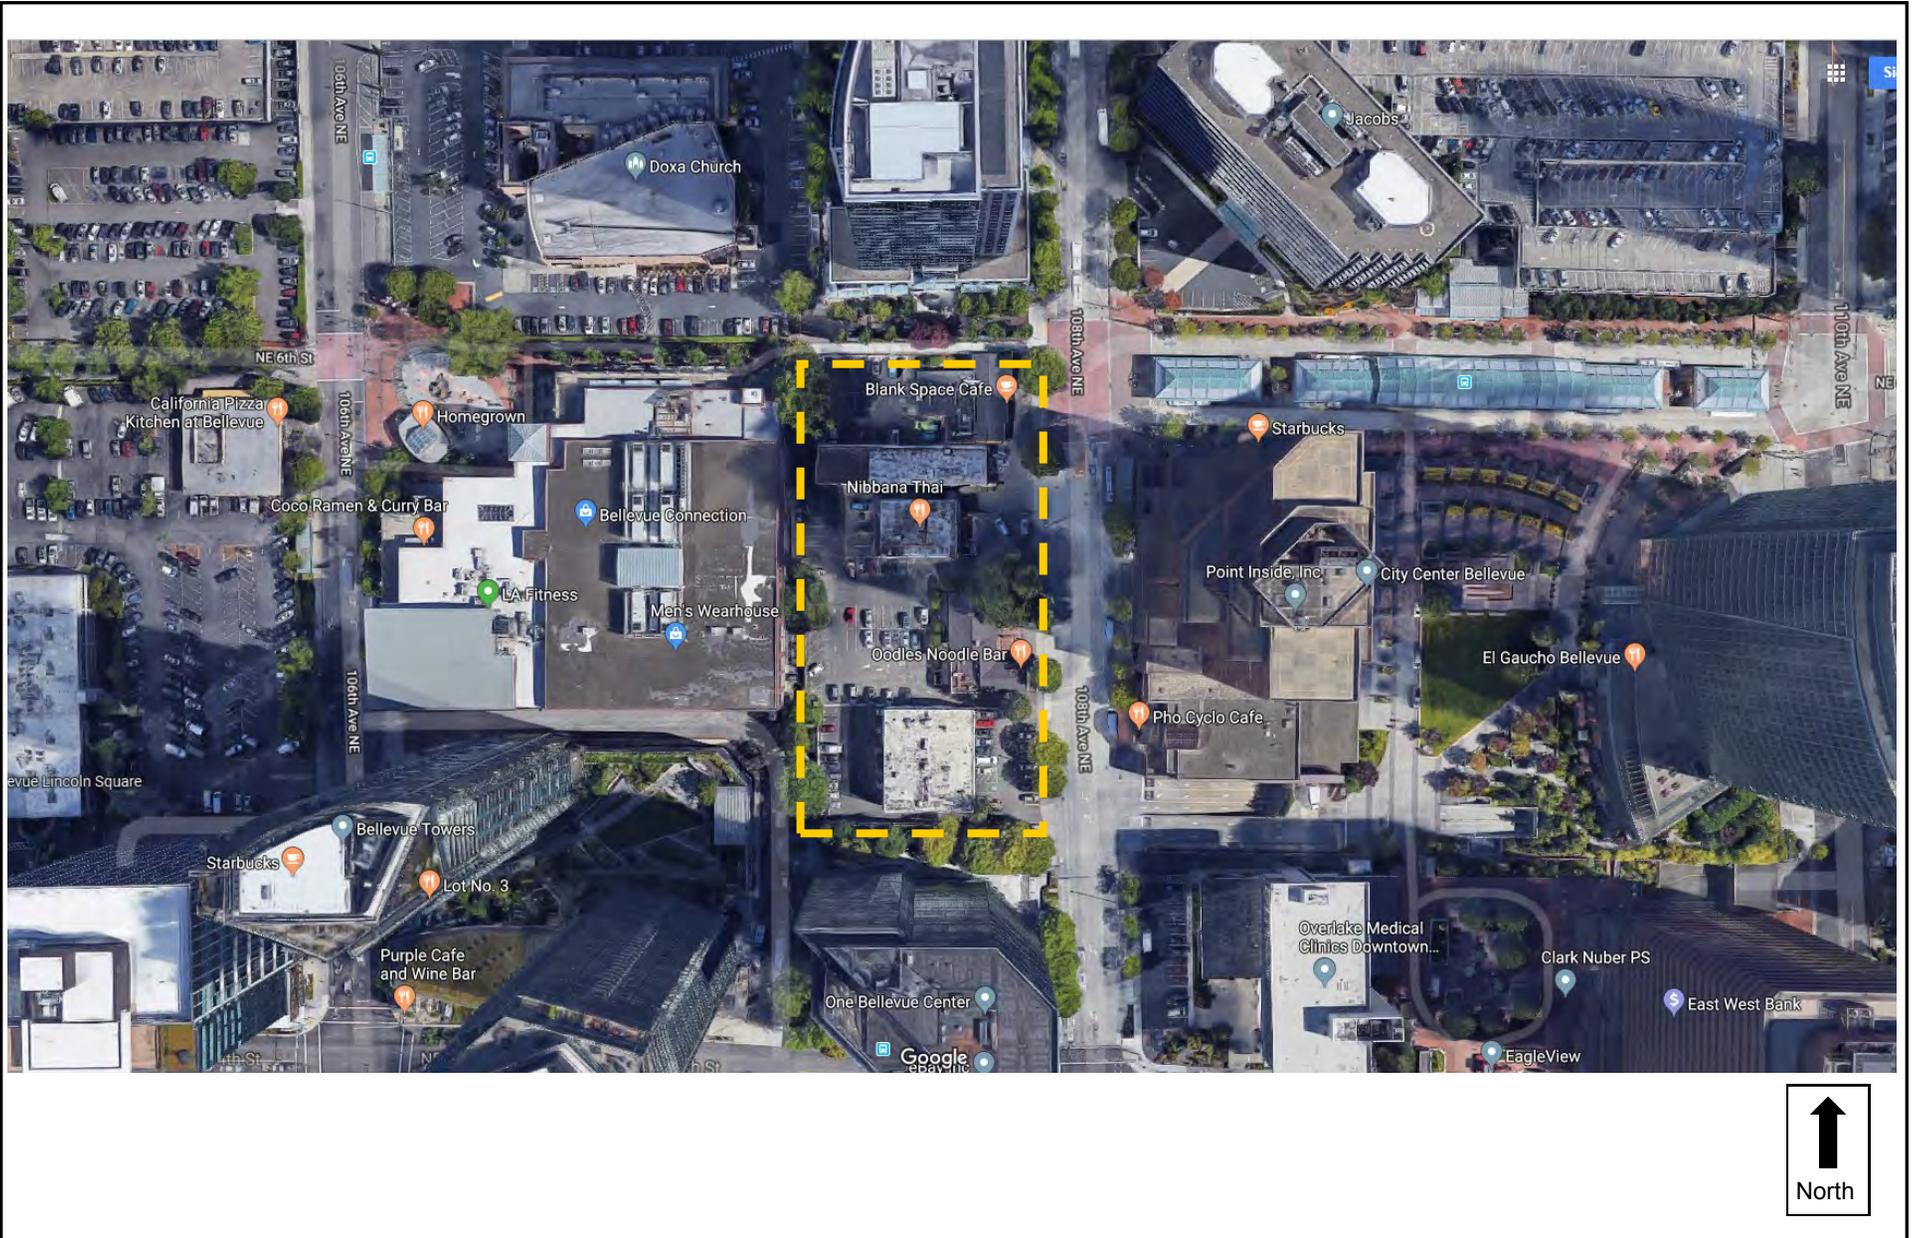
**Figure 2**  
Existing Conditions

*parking lots/spaces, all of which are planned to be removed as part of the project. See Figure 2 in Appendix A for more information.*

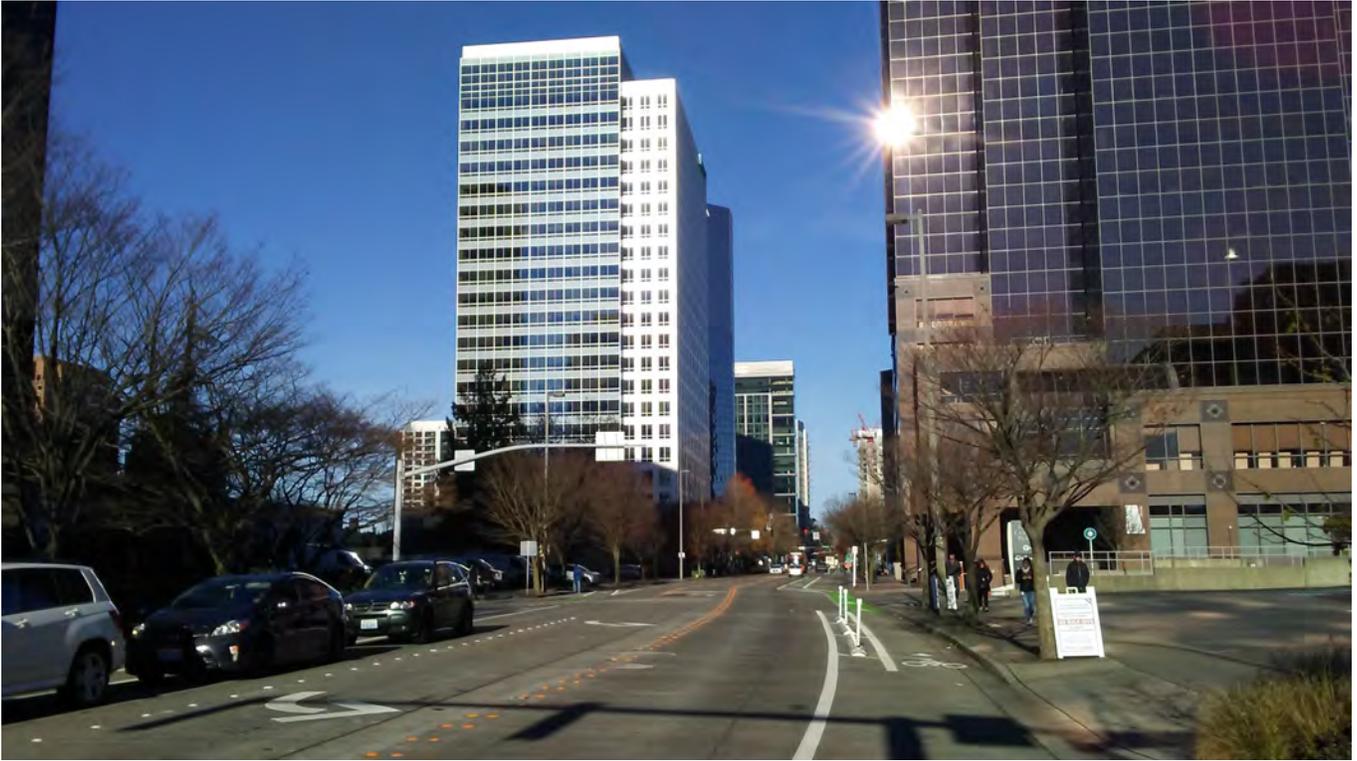
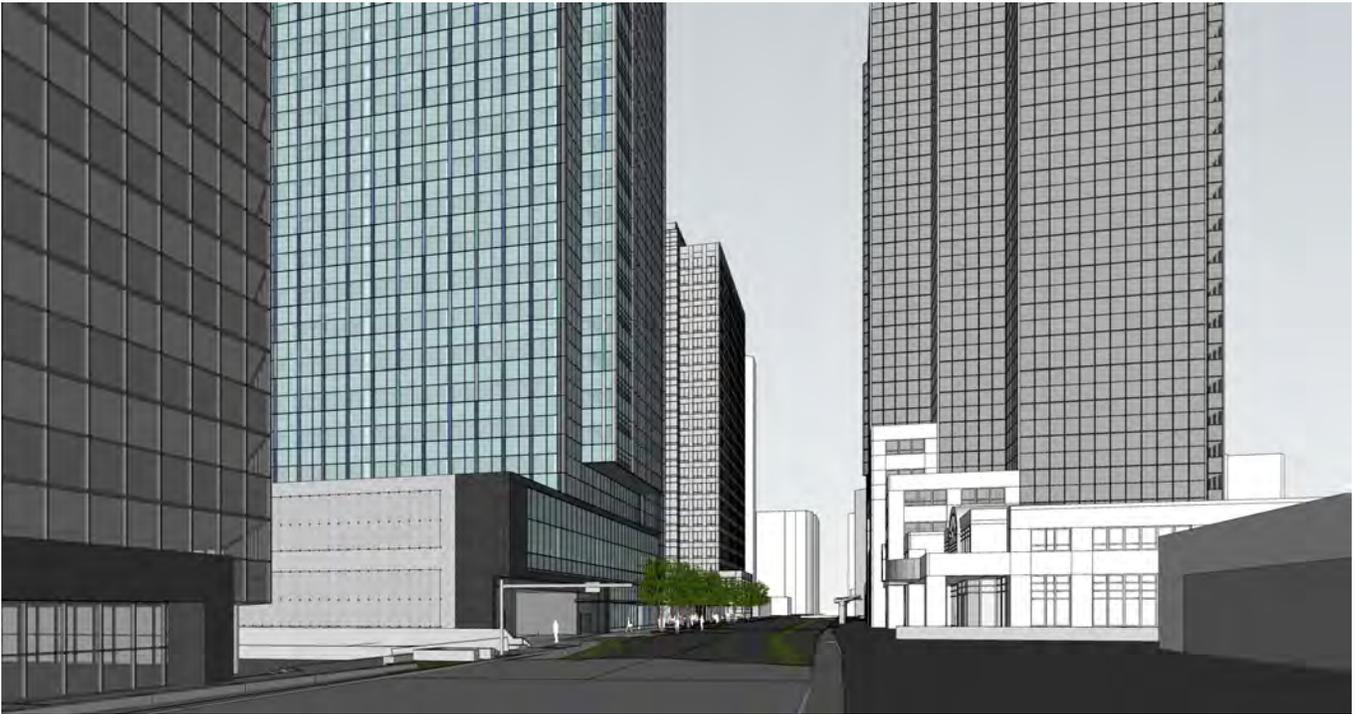
**Figure 8**  
Viewpoint 2—108th Avenue NE, Looking North

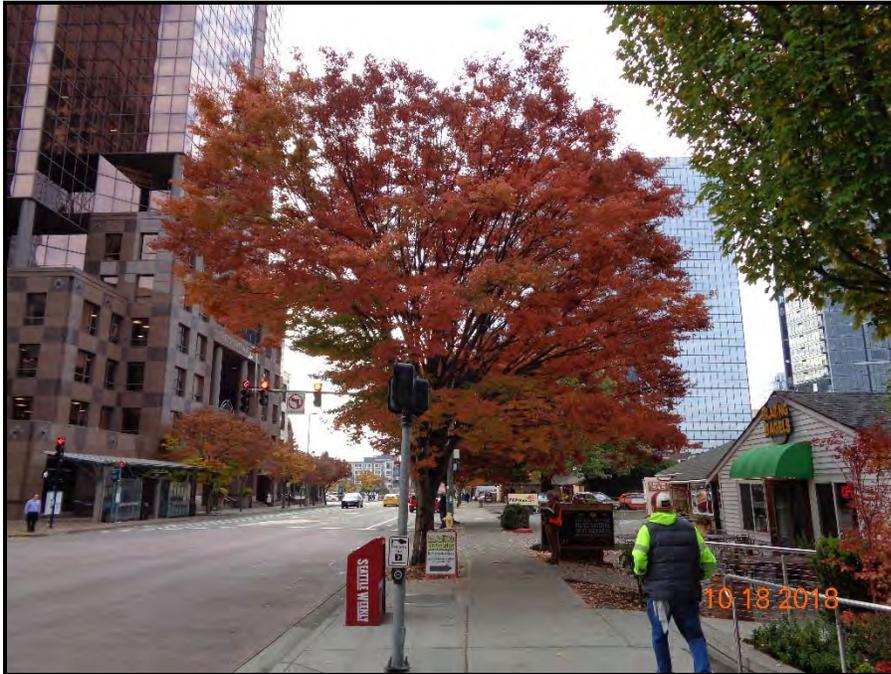
**Photo 1:** Tree A – Good health and structure

According to Patrick, the City of Bellevue requires easements of the property for public use 16 feet in from the curb, and 15 feet underground below that area. Tree A was measured with a DSH of 18 inches growing in a small planting bed with no grate near the curb. It has a canopy dripline of 22 feet which will likely need to be pruned for clearance of the new building. We recommend any pruning be carried out by a certified arborist according to ANSI A300 standards.

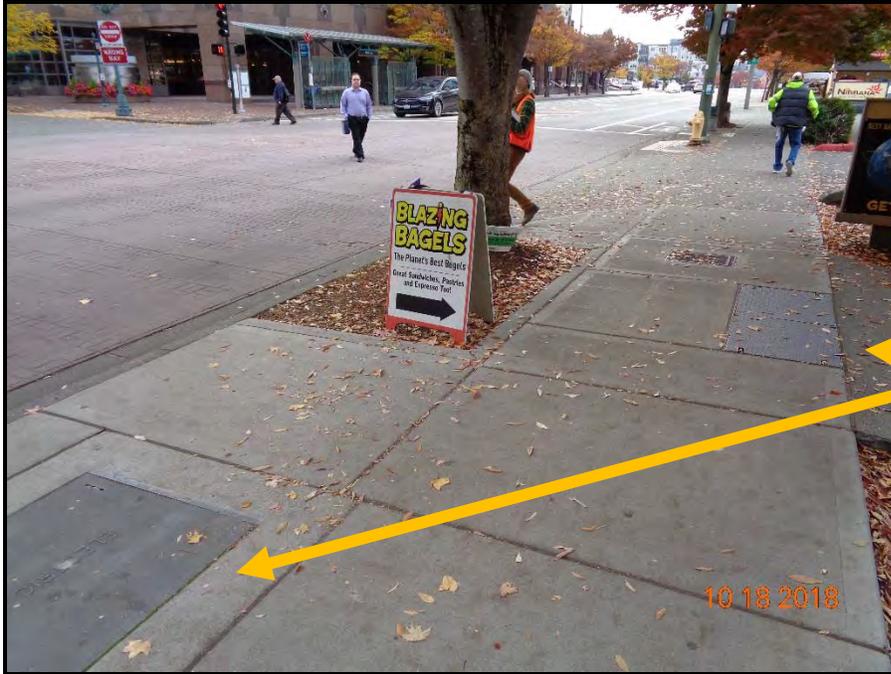
Utility vaults

**Photo 2:** Tree A – Sidewalk and adjacent utility vaults (yellow arrows)

There are utility vaults under the sidewalk to the north and west. The recommended TPZ for this tree is 12 feet from the face of the trunk. Due to the small planting area and impermeable surface around this tree, it is unlikely that any significant roots go below the 15 foot easement and would not be disturbed by excavation below that point for the parking garage. Typically tree roots in compacted areas are within the top two to four feet of soil. If the easement area is undisturbed during redevelopment, retention should not be a problem. If there need to be adjustments to any of the utility vaults or sidewalk areas, detailed plans should be reviewed so tree retention feasibility can be determined.

Sidewalk replacement may be feasible with safe retention of the tree if the existing sidewalk is carefully removed and grade is not significantly lowered. Lowering the grade of the sidewalk would likely result in substantial root disturbance.

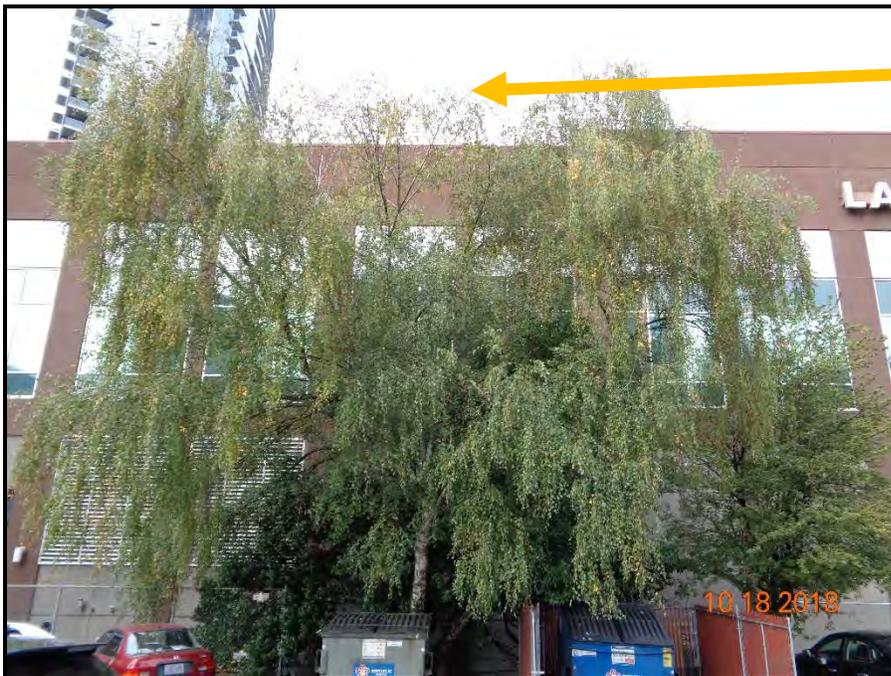
Dieback at the very top

**Photo 3:** Tree L – birch tree with a base that appears to be on adjacent property and canopy that significantly overhangs the site. This tree is exhibiting some signs of dieback and may be under attack by bronze birch borer. This tree is not a good candidate for retention and we recommend obtaining permission from the adjacent property owner for the removal of this tree.

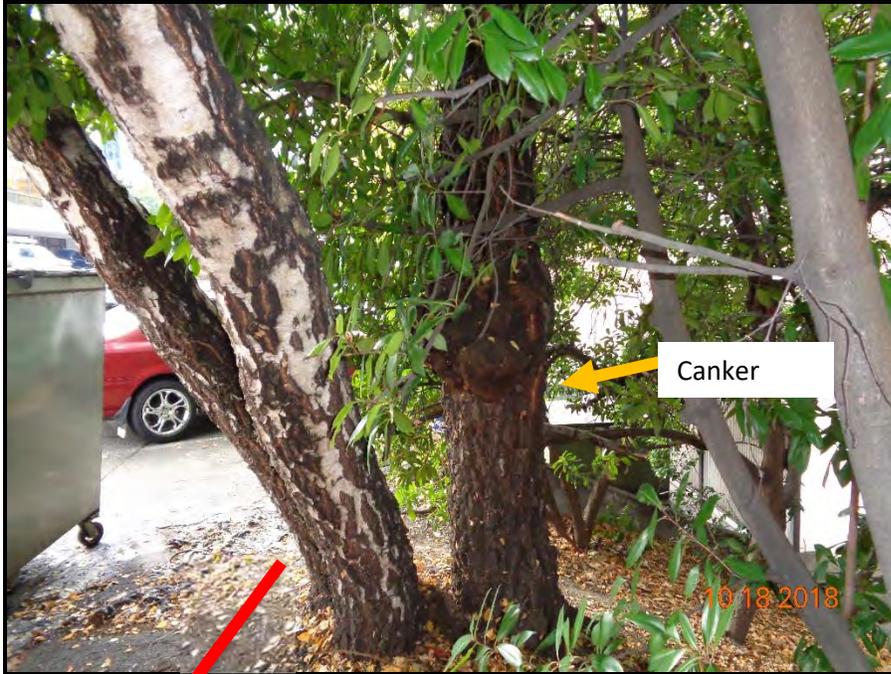
**Photo 4:** Tree L – cankers (yellow arrow) growing on the one of the stems. Red line illustrates approximate property boundary

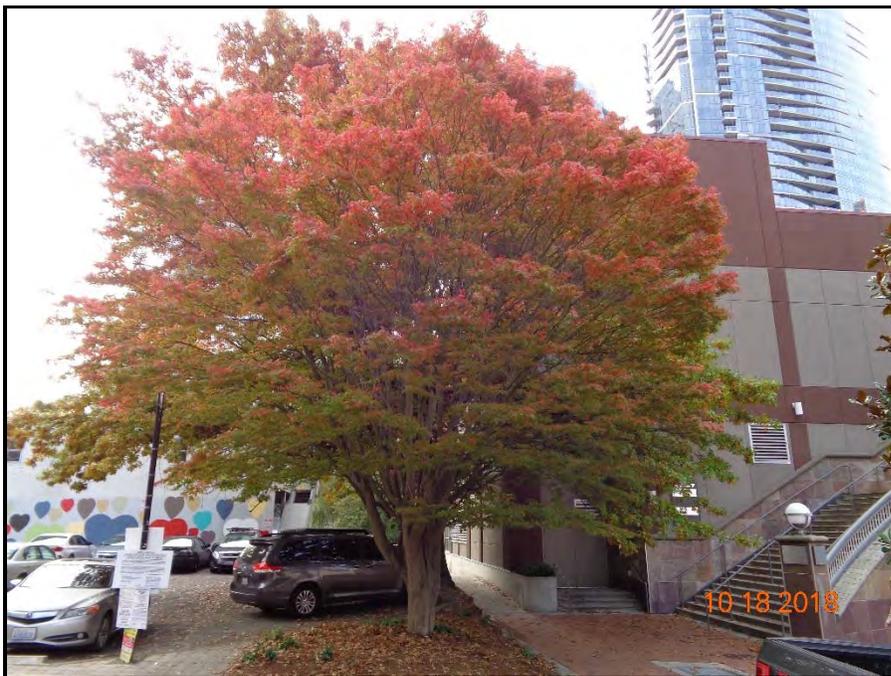
**Photo 5:** Tree 600 – Japanese maple considered for retention

Tree 600 was measured at 19.4 inches DSH and we would recommend a minimum tree protection zone (TPZ) of 13 feet from the face of the trunk to ensure healthy retention of this tree. Some encroachment into this TPZ may be feasible if needed, subject to detailed review of grading plans. Use of pneumatic excavation at the limit of disturbance should be considered as construction plans are developed so that roots can be exposed and cut cleanly, and then mechanical excavation can be carried out with no further damage to the tree's root system. The dripline of this tree is 20 feet radius and some clearance pruning may be needed to accommodate the new building. We recommend any pruning be carried out by a certified arborist according to ANSI A300 standards.

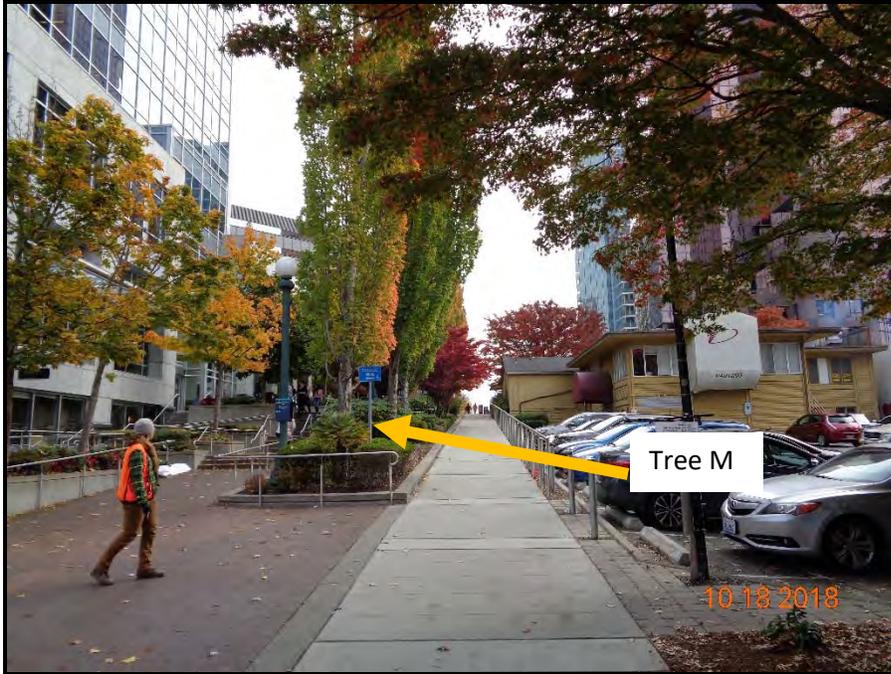
**Photo 6:** Trees M through R (background) – adjacent trees that may be impacted by sidewalk improvements.

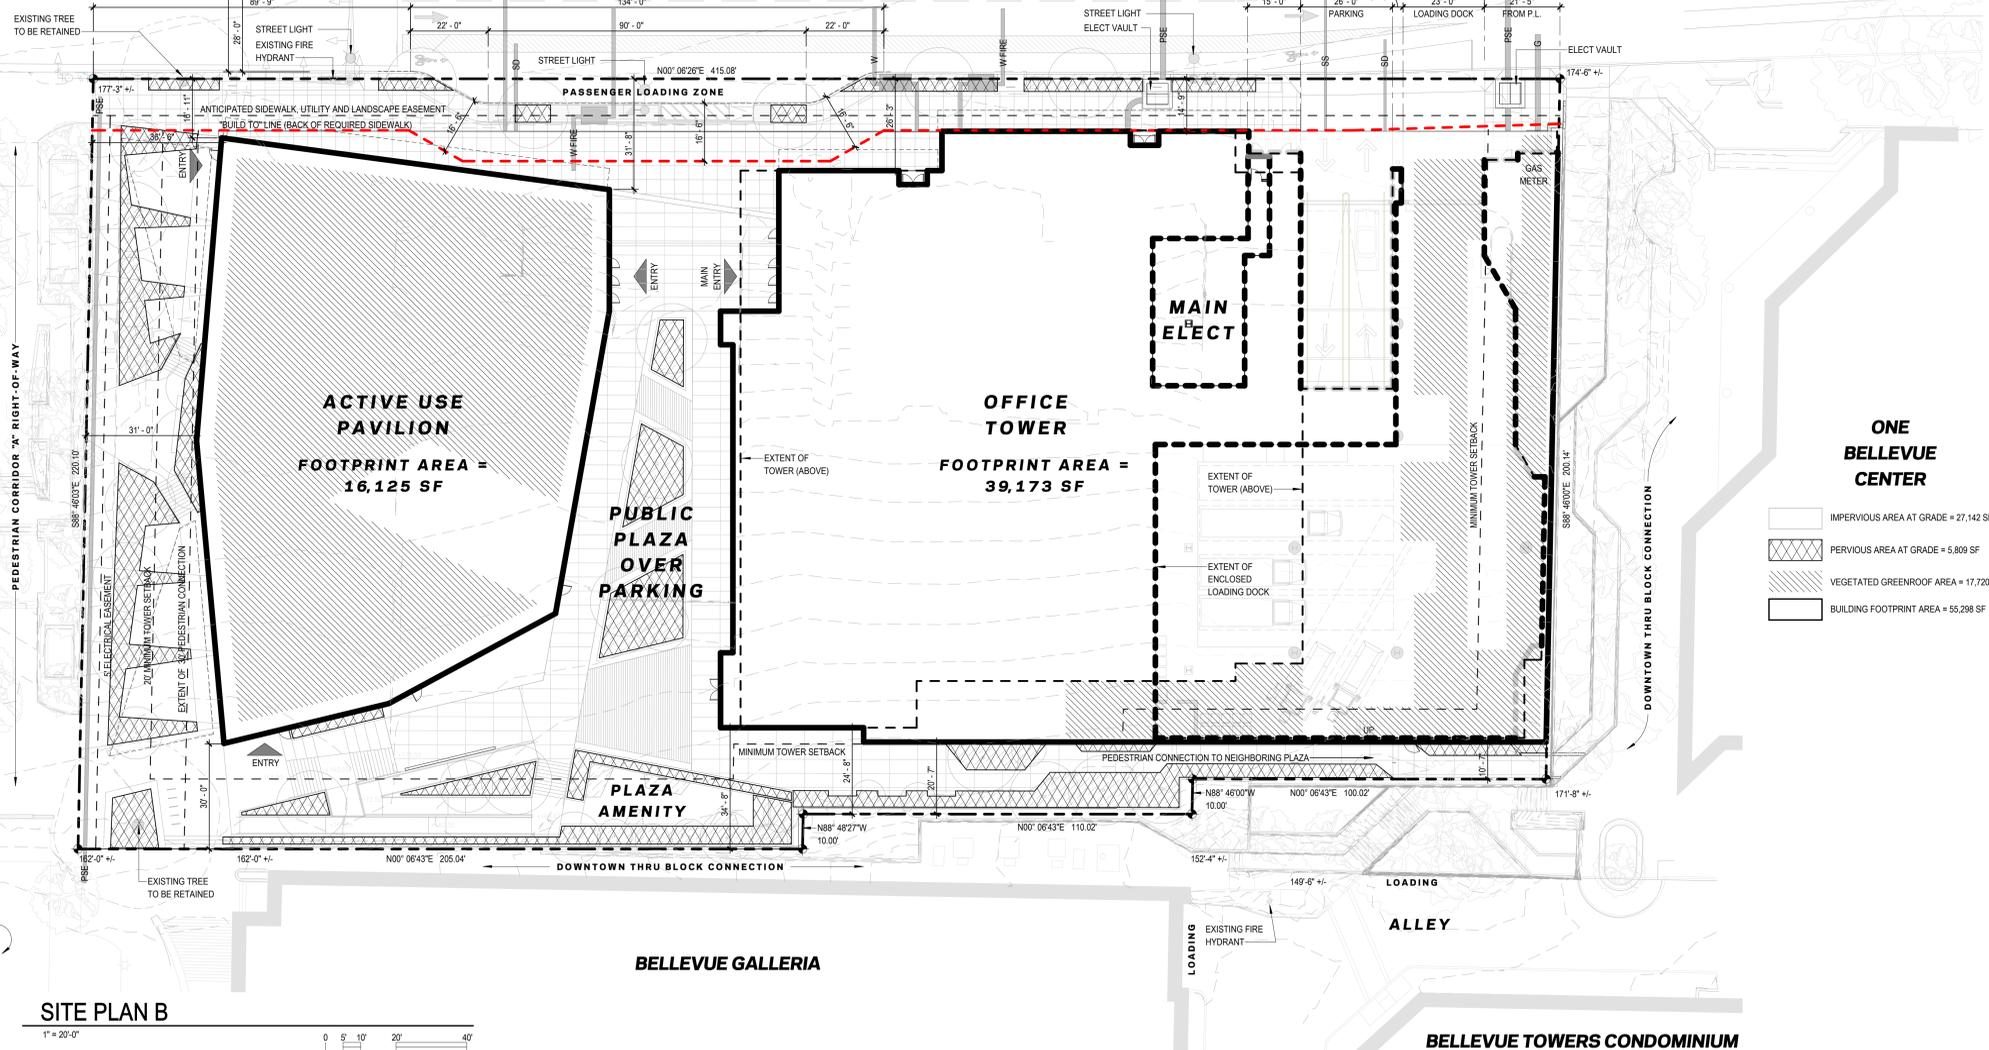
SHEET NUMBER G1002

SITE AREA 88,249 SF

SITE PLAN B
